PLANT SITE GROUNDWATER ASARCO EAST HELENA PLANT

This Plant Site Groundwater Summary considers groundwater on and in the vicinity of the plant.

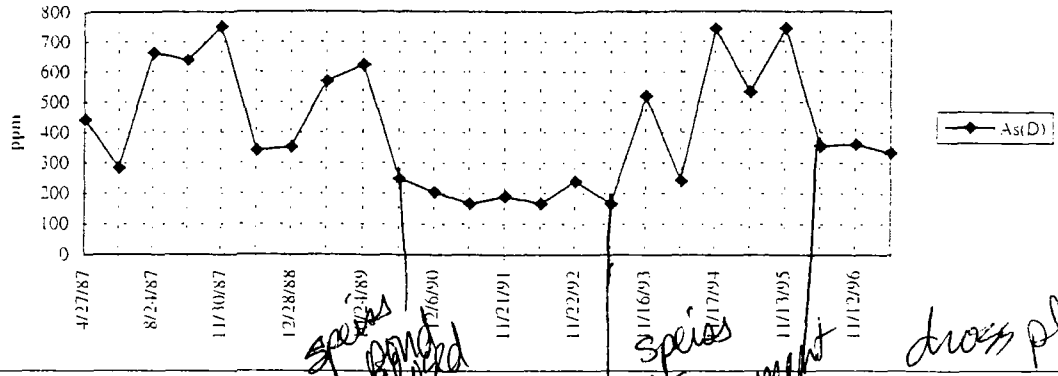
DH-21

species and closed

species pit replacement

cross plant

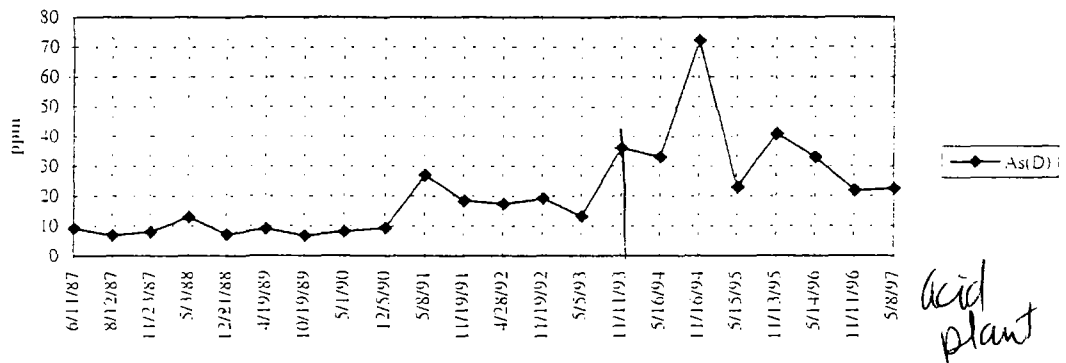
DH-22

acid plant

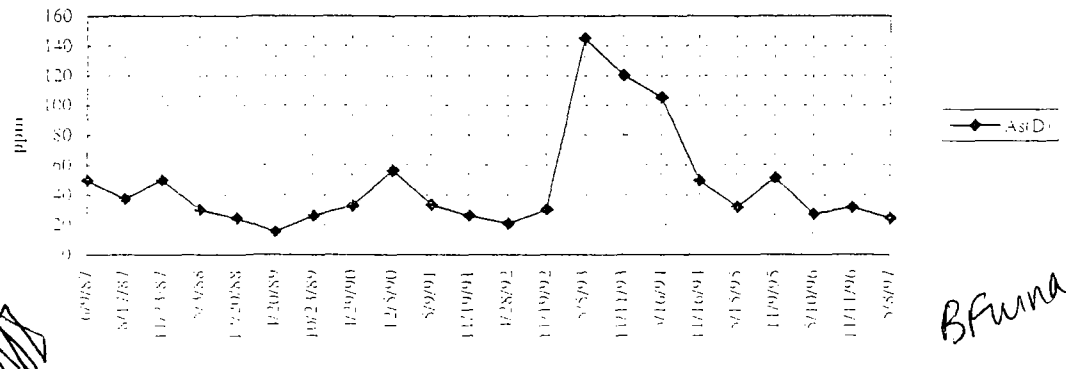
DH-27

- An exception is well DH-27, which recently (since 1996) has shown evidence of diesel fuel. The source of fuel constituents in this well is recent and attributed to plant machinery used and maintained in the area. This apparent source has since been removed from the area. Monitoring is on-going to further assess the potential impacts associated with recent fuel constituents in groundwater near this well.

BFurnace

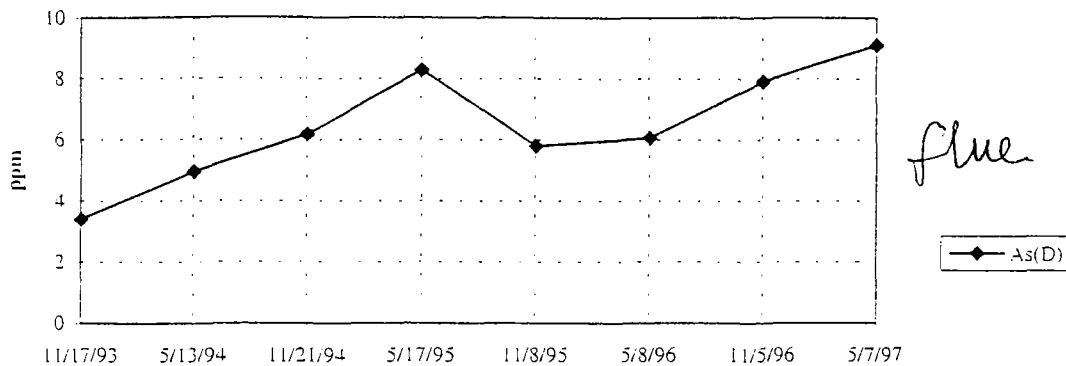
- APSD-13 Just inside (north) of the flue, southwest of D&L Storage Building
 - * Offsite
 - EH-60 Northeast of Highway 12 and 1st Street intersection.
- Post-RI/FS water quality from most private wells (5 wells monitored 1990 to 1994, 4 wells 1994 through 1997) showed little change from data collected during the RIFS. One well did show an increase in arsenic concentrations from 0.059 to 0.09 mg/l. These concentration were not observed in nearest shallow aquifer monitoring wells (EH-59 at 0.008 mg/l).

flue

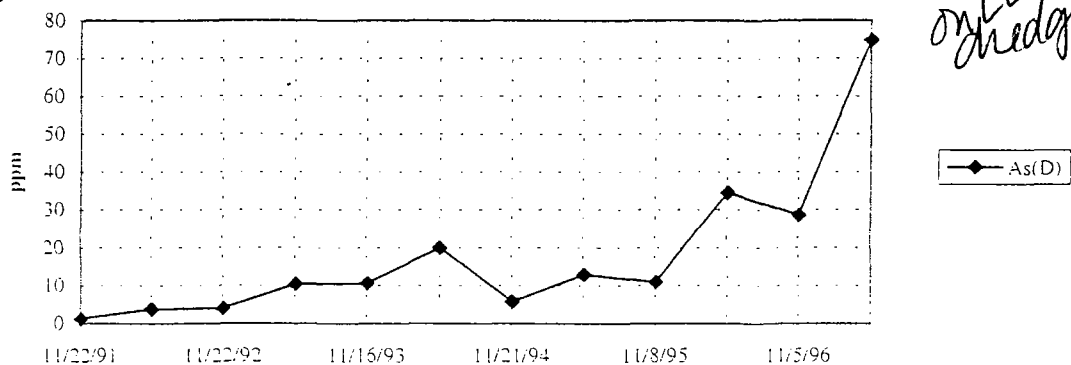
APSD-2

- Monitoring wells with notable trends of increasing arsenic concentrations during the Post-RI/FS period are:
 - * Plant Site wells
 - APSD-02 East edge of Lower Lake Dewatering Pad

on LL ~~basin~~ dredging area

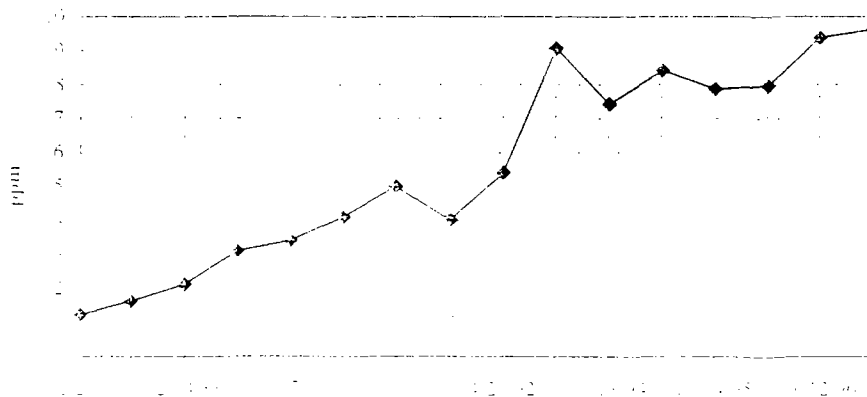
EH-60

could be caused by relationship w/organics

in process pond cleanup area
